Prepared for: [REDACTED]

Prepared by: Midwest Inspection & Testing
1475 bluff road
Pleasant Dale, NE 68423

20:34 June 03, 2019

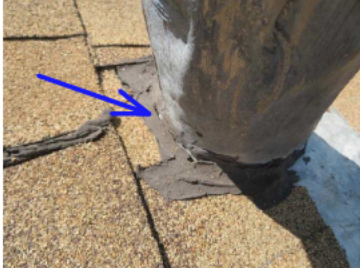
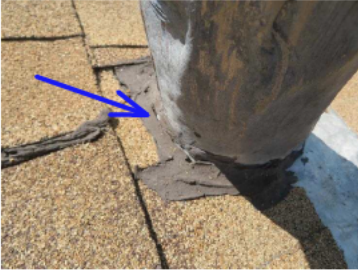
7. Plumbing Vents: Rubber boot is cracked/damaged and needs to be replaced to prevent moisture from entering the home.

1. Main Roof Surface Plumbing Vents: Rubber boot is cracked/dammaged and needs to be replaced to prevent moisture from entering the home.

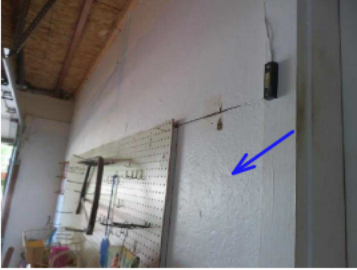
8. Walls: not fire rated - Wall is not fire resistant to the home. Recommend a qualified contractor to provide cost for repair.

5. Side Garage Walls: not fire rated - Wall is not fire resistant to the home. Recommend a qualified contractor to provide cost for repair.

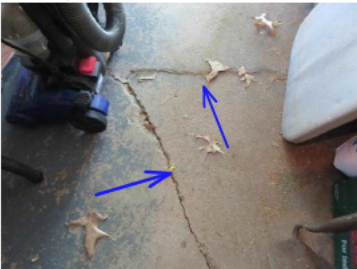
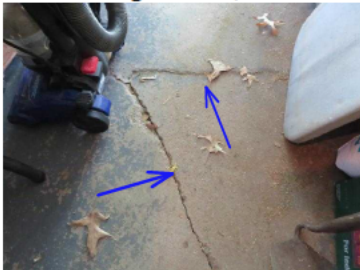
9. Floor/Foundation: Poured slab. Minor floor cracks noted-seal cracks.

3. Side Garage Floor/Foundation: Poured slab. Minor floor cracks noted-seal cracks.

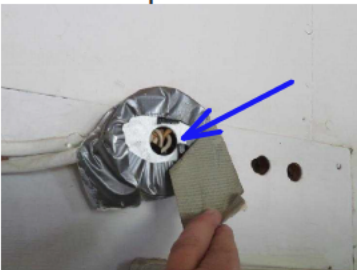
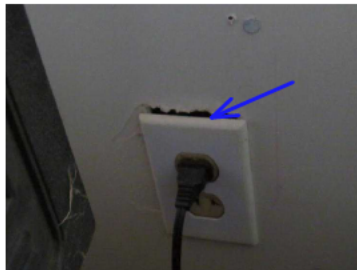
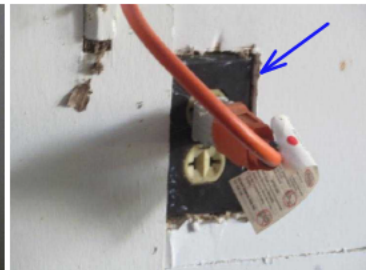
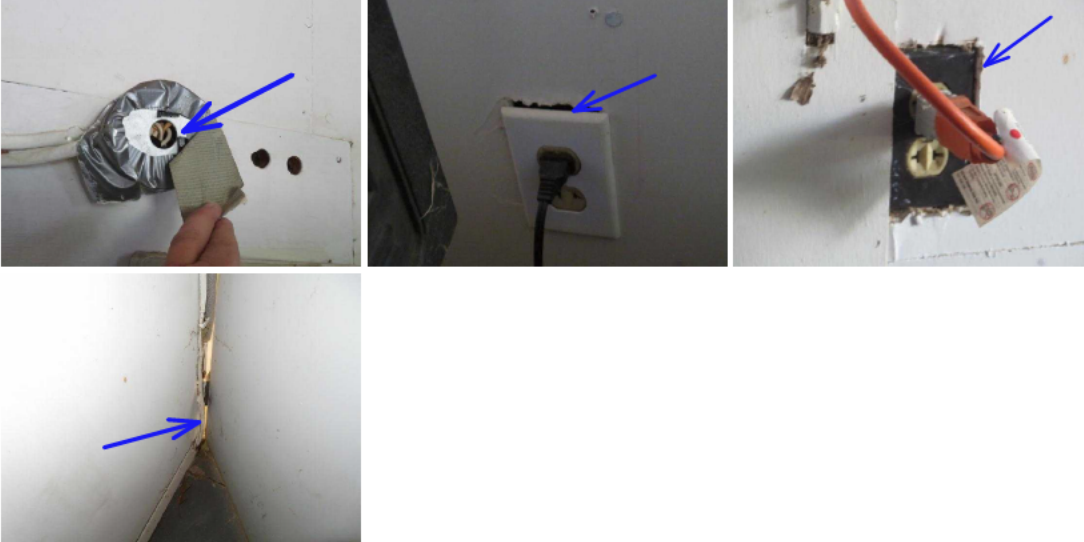
10. Electrical: 110 VAC. Non-GFCI circuit and the junction box needs a cover...not tape. Romex wire needs to be within the wall or in conduit. A licensed electrician is recommended to evaluate and estimate repairs.

6. Side Garage Electrical: 110 VAC. Non-GFCI circuit and the junction box needs a cover...not tape. Romex wire needs to be within the wall or in conduit. A licensed electrician is recommended to evaluate and estimate repairs.

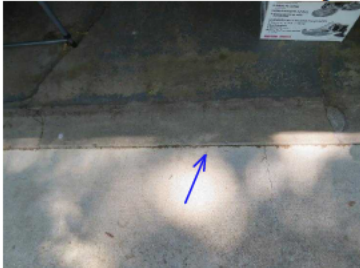
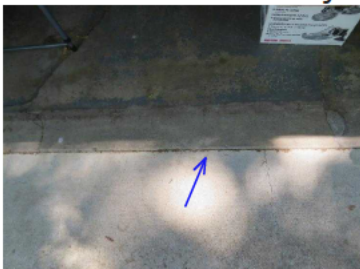
- 1. Drive: Concrete. Need a joint between drive and garage floor.

4. Drive: Concrete. Need a joint between drive and garage floor.

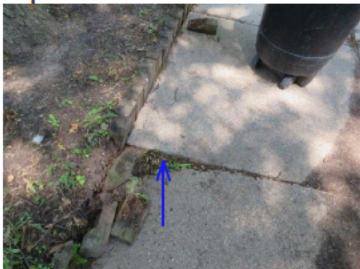
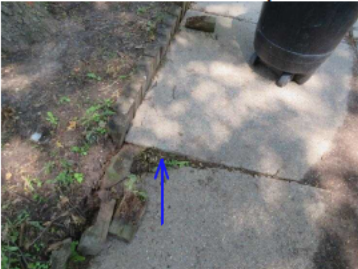
- 2. Walks: Concrete. Trip hazard. A qualified contractor is recommended to evaluate and estimate repairs.

7. Walks: Concrete. Trip hazard. A qualified contractor is recommended to evaluate and estimate repairs.

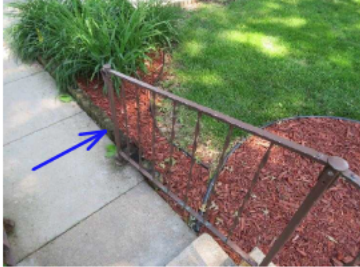
4. Porch: Concrete. railing a little loose.

5. Porch: Concrete. railing a little loose.

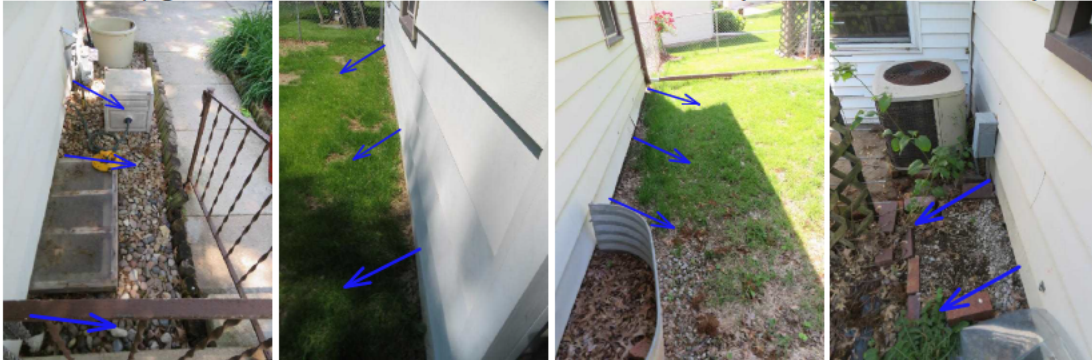
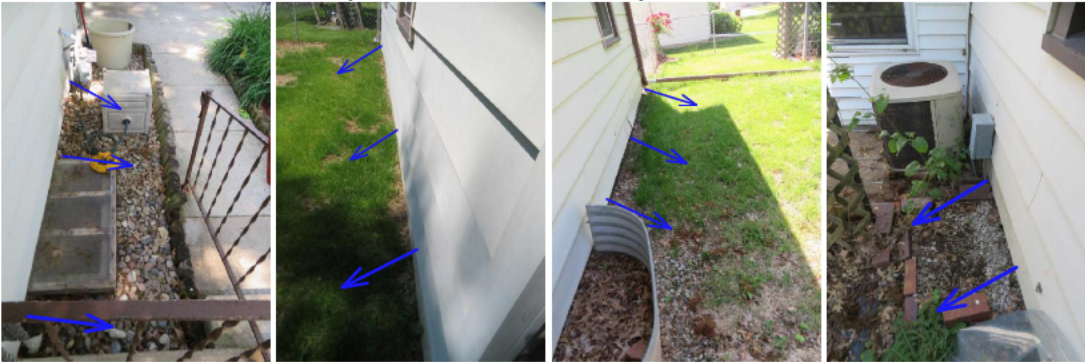
6. Grading: Flat. - Improper soil slope around the home, I recommend the addition of fill dirt (clay) to improve water management. (Water management consists of clay dirt built around the foundation, gutters clean and extensions 4 to 6 feet away from the foundation.)

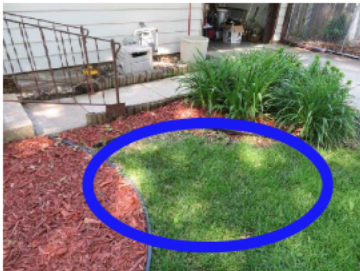
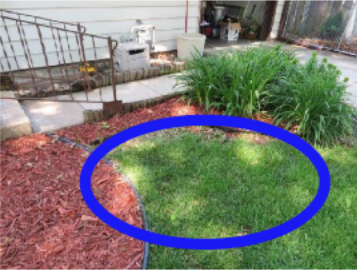
7. Swale: Recommend improvements be made to the grade, swale slope and depth to improve water control.

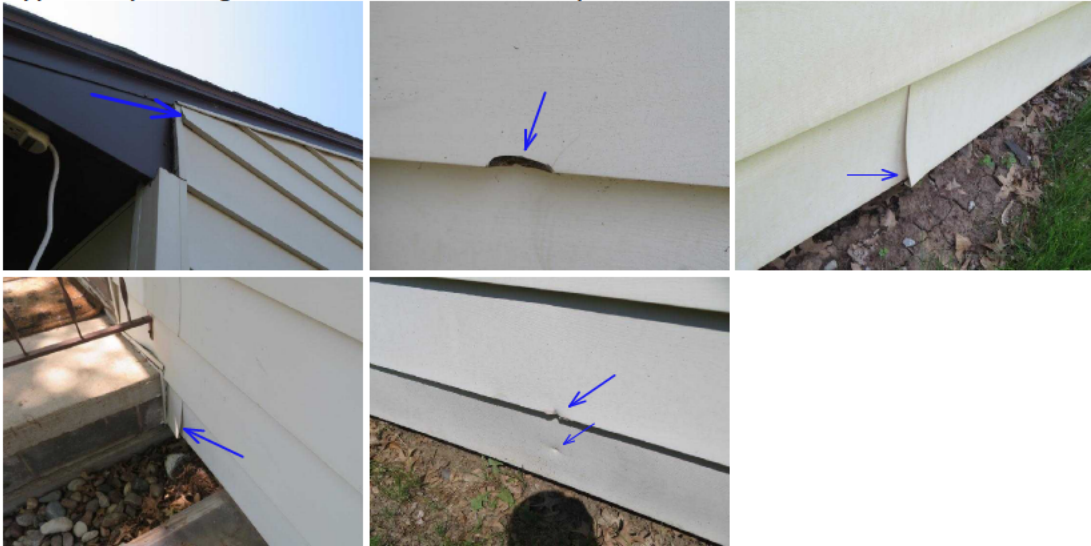
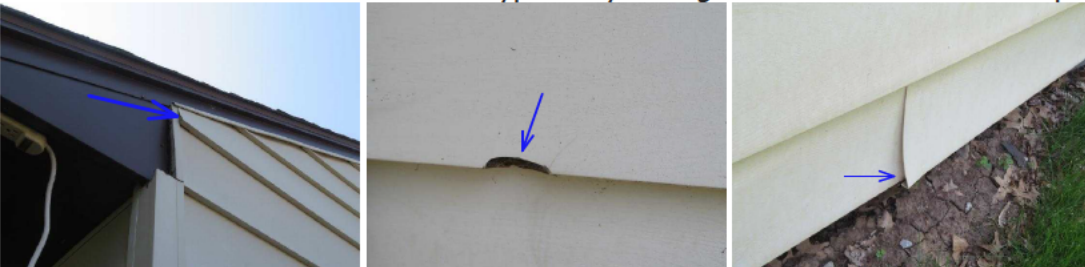
1. Type: Vinyl siding. Nick and loose in a few spots

8. All exterior surfaces Exterior Surface Type: Vinyl siding. Nick and loose in a few spots

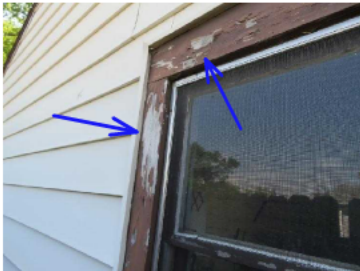
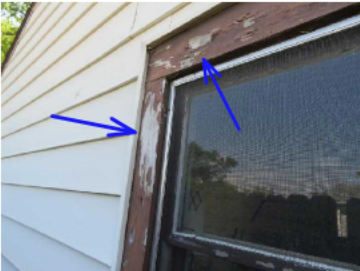
2. Door Bell:
 3. Entry Doors: Wood.
 4. Trim: Wood and metal. Need seal and paint wood to protect it from the elements.

9. Trim: Wood and metal. Need seal and paint wood to protect it from the elements.

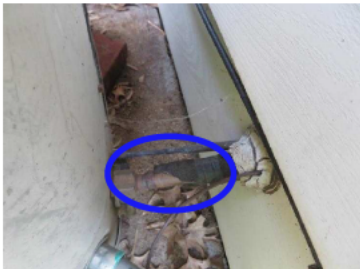
8. Refrigerant Lines: Torn insulation and needs to be replaced/added to keep cooling lines insulated.

12. Main AC System Refrigerant Lines: Torn insulation and needs to be replaced/added to keep cooling lines insulated.

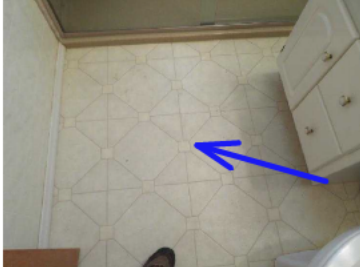
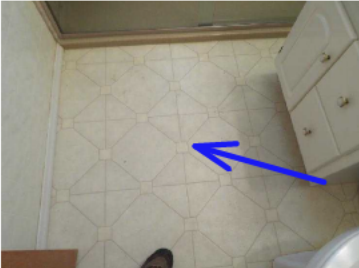
1. Doors: Hollow wood.
2. Closet:
3. Ceiling: Texture.
4. Walls: Paint and paneling.
5. Floor: Linoleum. The floor squeaks when walked on.

13. 1st floor main Bathroom Floor: Linoleum. The floor squeaks when walked on.

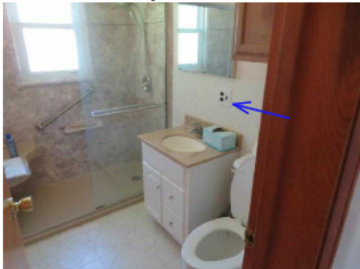
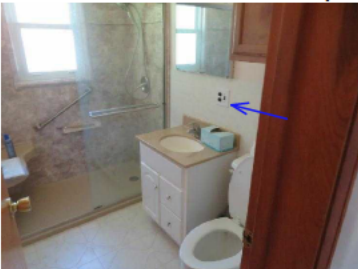
6. Windows: Vinyl double hung.
7. Electrical: 110 VAC. Non-GFCI circuit. A licensed electrician is recommended to evaluate and estimate repairs.

8. 1st floor main Bathroom Electrical: 110 VAC. Non-GFCI circuit. A licensed electrician is recommended to evaluate and estimate repairs.

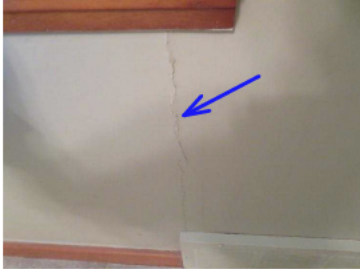
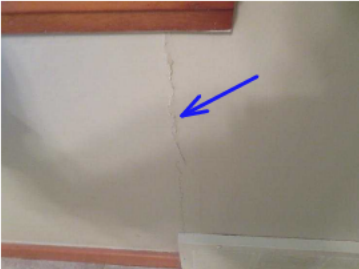
1. Doors: Hollow wood.
2. Closet: Single.
3. Ceiling: Texture.
4. Walls: Paint. Cracks present

14. 1st Floor N.W. Bedroom Walls: Paint. Cracks present

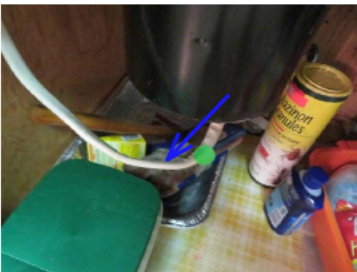
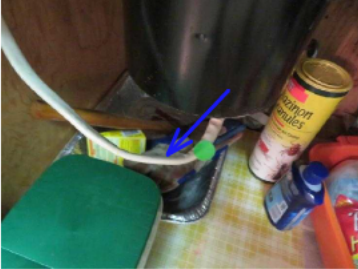
7. Disposal: The cord needs to be in conduit to prevent it from being cut and causing electric shock.

9. 1st Floor Kitchen Disposal: The cord needs to be in conduit to prevent it from being cut and causing electric shock.

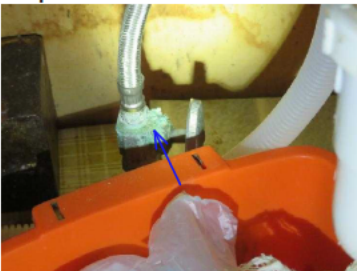
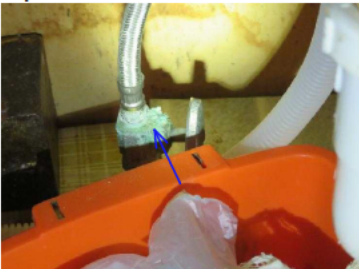
9. Plumbing/Fixtures: PVC. - Cold water line showing corrosion but not leaking at time of inspection.

15. 1st Floor Kitchen Plumbing/Fixtures: PVC. - Cold water line showing corrosion but not leaking at time of inspection.

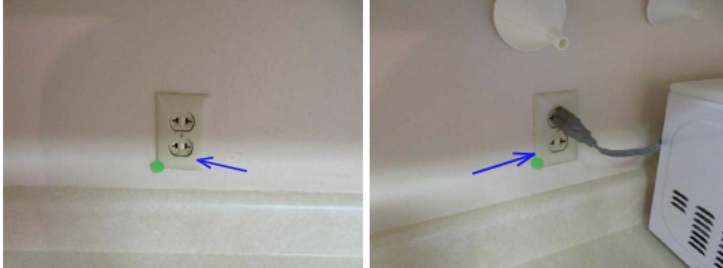
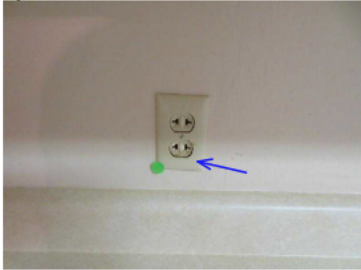
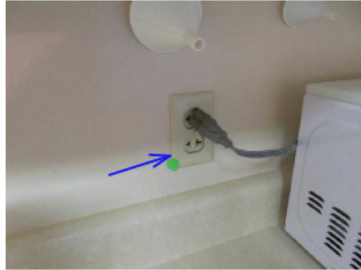
10. Electrical: Non-GFCI circuit. A licensed electrician is recommended to evaluate and estimate repairs.

10. 1st Floor Kitchen Electrical: Non-GFCI circuit. A licensed electrician is recommended to evaluate and estimate repairs.

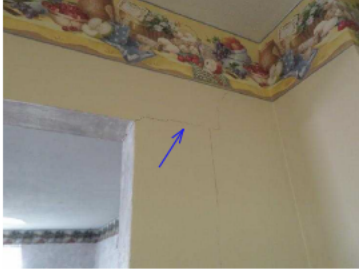
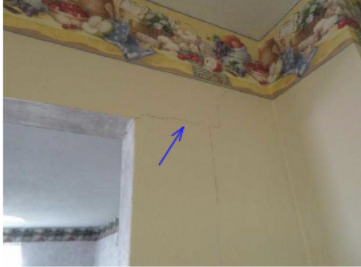
11. Counter Tops:
12. Trash Compactor:
13. Cabinets: Wood.
14. Pantry:
15. Ceiling: Texture.
16. Walls: Paint. Cracks present.

16. 1st Floor Kitchen Walls: Paint. Cracks present.

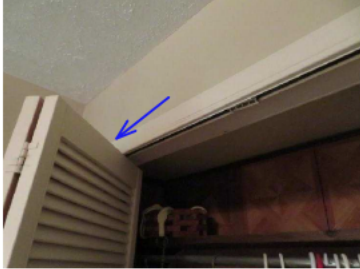
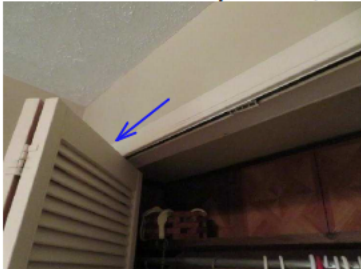
1. Closet: Single. Door off track.

18. 1st Floor Laundry Room/Area Closet: Single. Door off track.

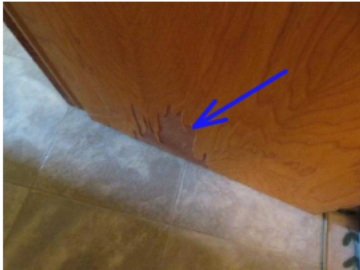
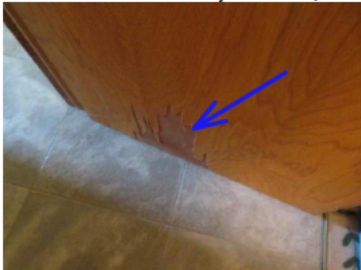
2. Ceiling: Texture.
3. Walls: Paint.
4. Floor: Linoleum.
5. Doors: Hollow wood. some damage.

19. 1st Floor Laundry Room/Area Doors: Hollow wood. some damage.

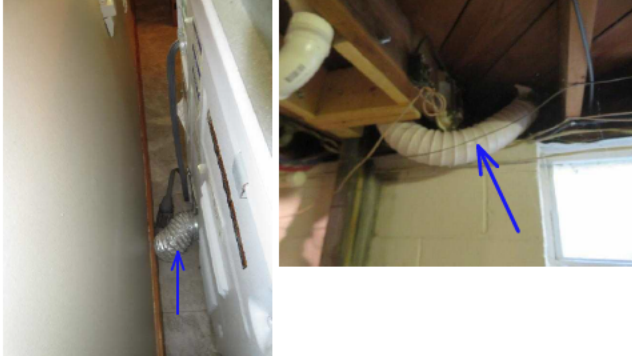
14. Dryer Vent: Metal flex. Recommend rigid pipe.

20. 1st Floor Laundry Room/Area Dryer Vent: Metal flex. Recommend rigid pipe.

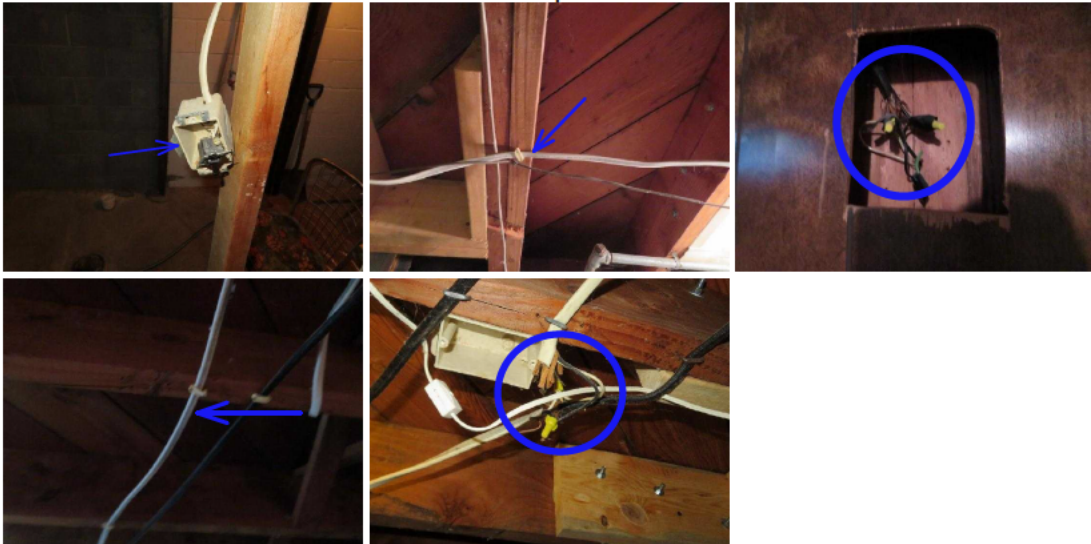
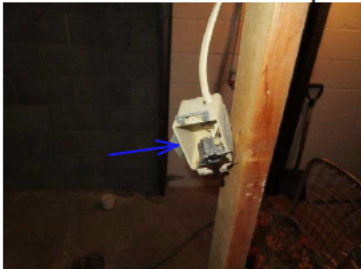
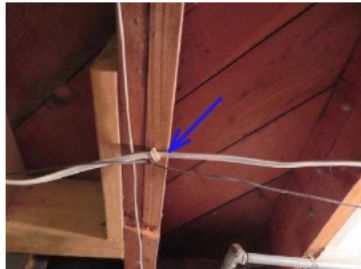
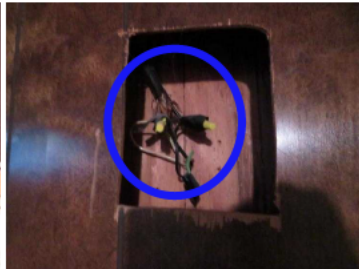
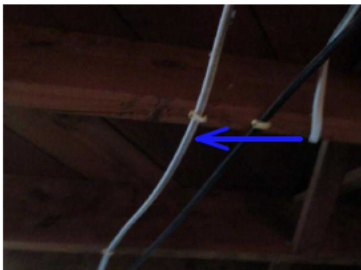
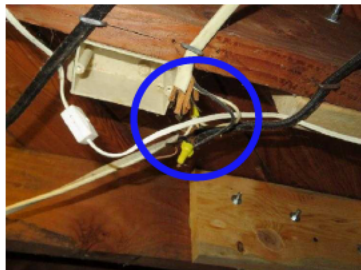
1. Ceiling: Exposed framing and drywall
2. Walls: Fire rated.
3. Floor: Poured.
4. Doors:
5. Windows: Steel frame.
6. Electrical: Romex needs to be through the joist and not under. wires needs to be in a covered junction boxes and switch needs a cover and attached to the wall. A licensed electrician is recommended to evaluate and estimate repairs.

11. Main Basement Electrical: Romex needs to be through the joist and not under. wires needs to be in a covered junction boxes and switch needs a cover and attached to the wall. A licensed electrician is recommended to evaluate and estimate repairs.

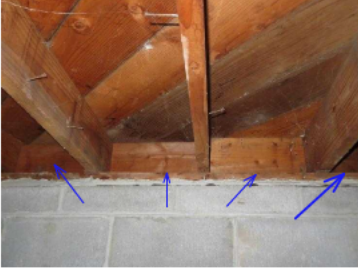
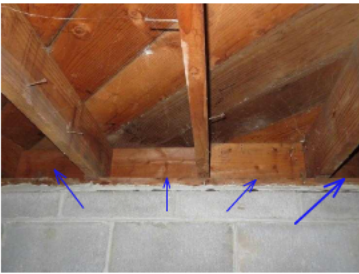
- 7. Smoke Detector: Not tested. Recommend once you move in to test and replace batteries for peace of mind.
- 8. HVAC Source: Heating system register.
- 9. Vapor Barrier:
- 10. Insulation: No insulation present.

21. Main Basement Insulation: No insulation present.

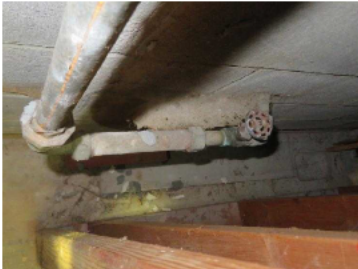
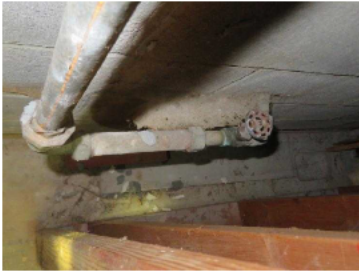
- 1. Service Line: Galvanized. showing corrosion but not leaking at time of inspection.

22. Service Line: Galvanized. showing corrosion but not leaking at time of inspection.

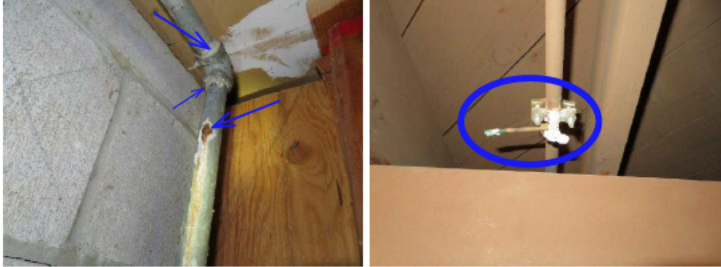
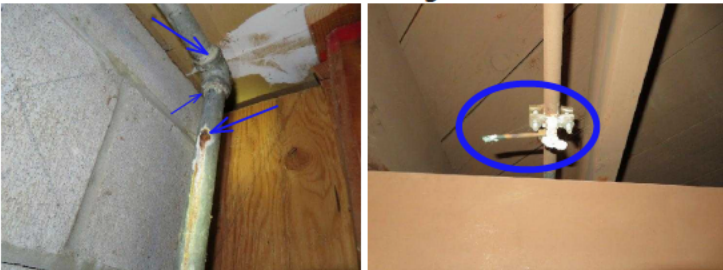
3. Water Lines: Galvanized. showing corrosion but not leaking at time of inspection.

23. Water Lines: Galvanized. showing corrosion but not leaking at time of inspection.

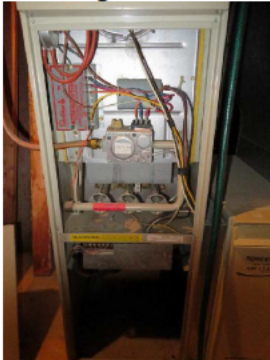
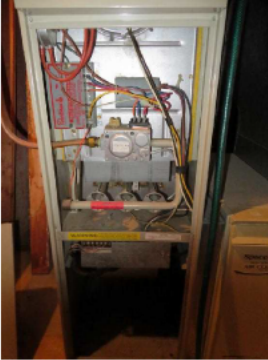
1. Heating System Operation: Did not run up the unit due to the temperature outside. See heat exchangers comments.

12. Basement Heating System Heating System Operation: Did not run up the unit due to the temperature outside. See heat exchangers comments.

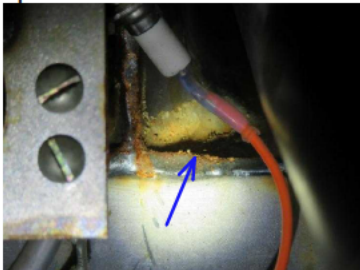
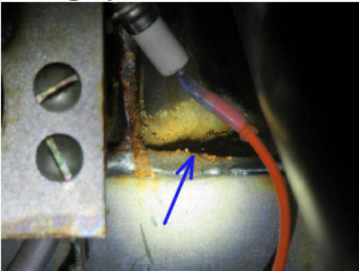
2. Manufacturer: Lennox
3. Model Number: g16q3757 Serial Number: [REDACTED]
4. Type: Forced air. Capacity: 75,000 BTUR
5. Area Served: Whole building. Approximate Age: 31 years old.
6. Fuel Type: Natural gas
7. Heat Exchanger: Showing rust and debris. Recommend inspection by a qualified heating specialist.

13. Basement Heating System Heat Exchanger: Showing rust and debris. Recommend inspection by a qualified heating specialist.

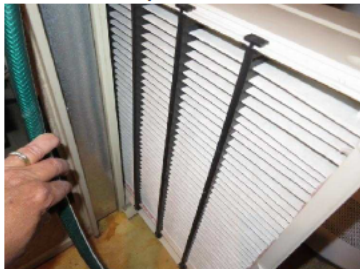
8. Unable to Inspect: 70%
9. Blower Fan/Filter: filter a little dirty.

24. Basement Heating System Blower Fan/Filter: filter a little dirty.

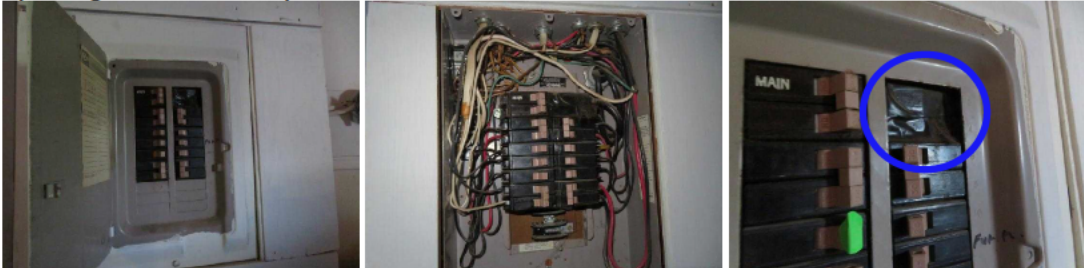
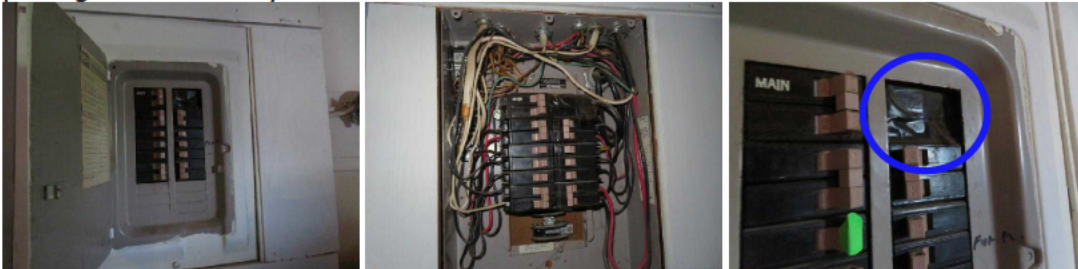
- 1. Manufacturer: Cutler-Hammer. Open "knock-out" hole- insert "blank-out" cap to close off opening. Evaluation by a licensed electrician is recommended.

14. Garage Electric Panel Manufacturer: Cutler-Hammer. Open "knock-out" hole- insert "blank-out" cap to close off opening. Evaluation by a licensed electrician is recommended.

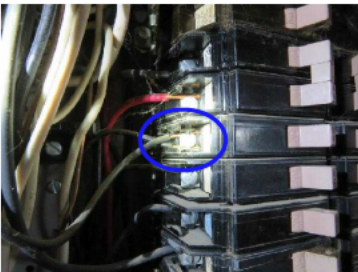
- 2. Maximum Capacity: 100 Amps
- 3. Main Breaker Size: 100 Amps
- 4. Breakers: Copper and Aluminum. - Double taps are present at breakers. These circuits need to be moved to their own circuit breaker and cannot share a breaker. It is recommended that a qualified electrician inspect the new circuits and properly connect the new circuits to an individual breaker for each circuit.

15. Garage Electric Panel Breakers: Copper and Aluminum. - Double taps are present at breakers. These circuits need to be moved to their own circuit breaker and cannot share a breaker. It is recommended that a qualified electrician inspect the new circuits and properly connect the new circuits to an individual breaker for each circuit.

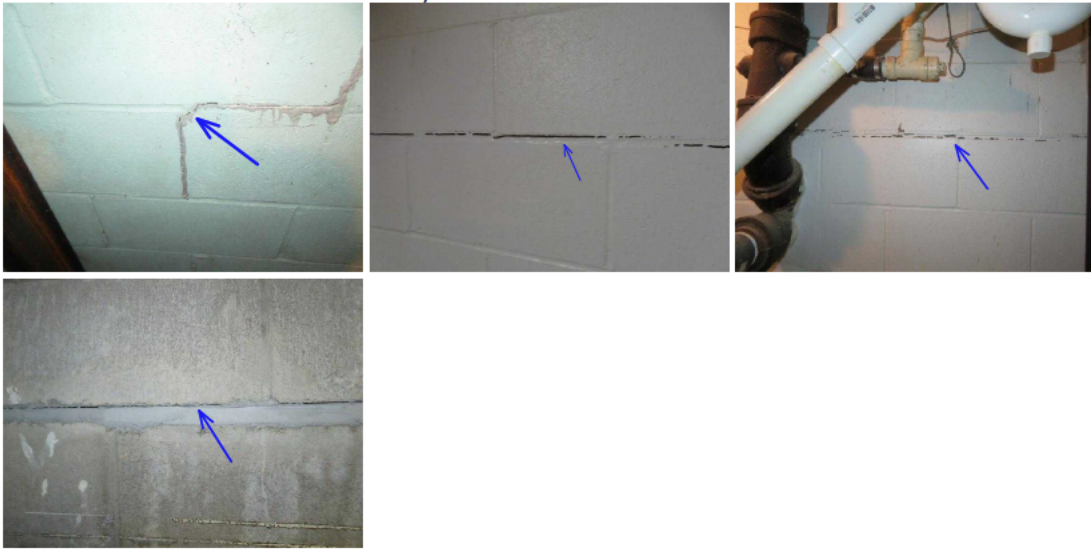
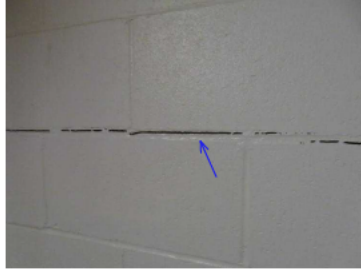
- 1. Structure Type: Wood frame.
- 2. Foundation: Block. Cracks noted, seal and monitor for future movement.

25. Foundation: Block. Cracks noted, seal and monitor for future movement.

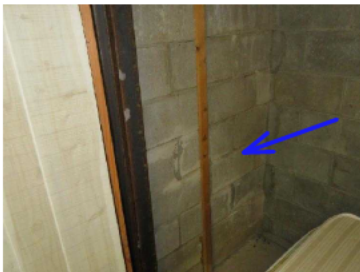
- 3. Differential Movement: Cracks and bow will require monitoring. We have from 1 to 1 1/2 movement on North and South walls.

26. Differential Movement: Cracks and bow will require monitoring. We have from 1 to 1 1/2 movement on North and South walls.

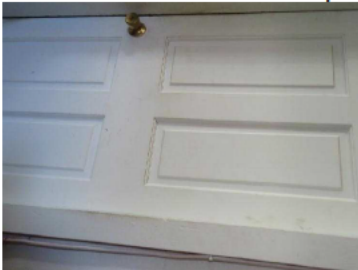
6. Service Doors: Wood. - Entry door not rated for fire. A qualified contractor is recommended to evaluate and estimate repairs.

4. Side Garage Service Doors: Wood. - Entry door not rated for fire. A qualified contractor is recommended to evaluate and estimate repairs.
