Prepared for: [REDACTED]

Prepared by: Midwest Inspection & Testing
1475 bluff road
Pleasant Dale, NE 68423

20:34 June 03, 2019

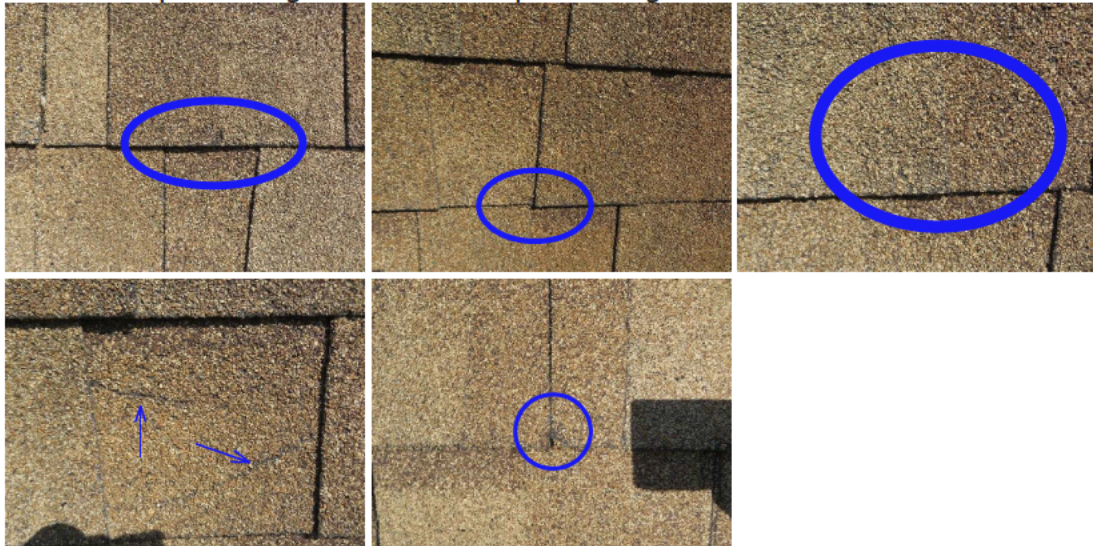
2. Material: Asphalt shingle. little nicked up but still good life left.

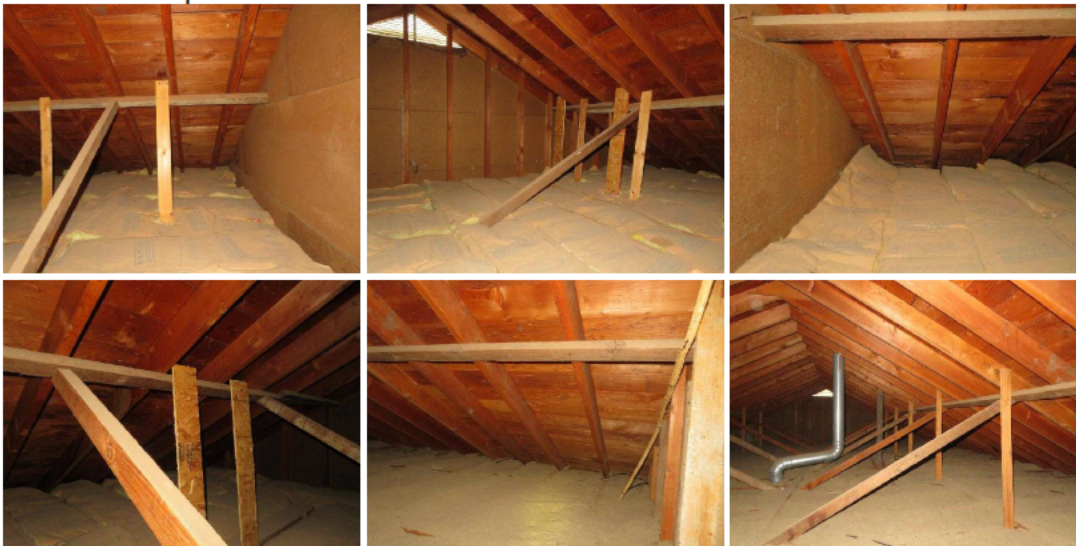
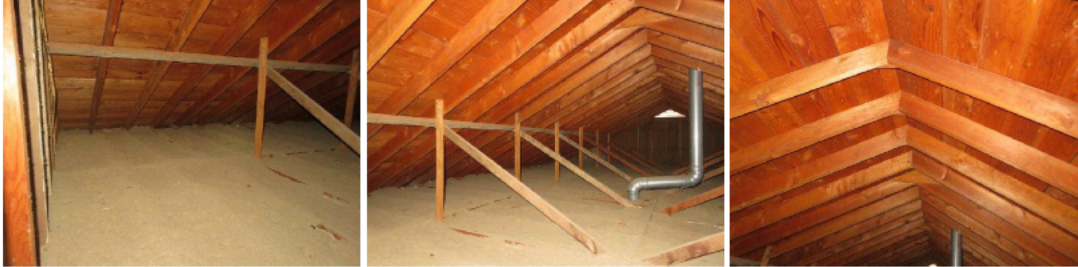
1. Method of Inspection: From the attic access

- 2. Roof Framing: 2x6 Rafter.
- 3. Sheathing: Dimensional wood.
- 4. Ventilation: Gable and soffit vents.
- 5. Insulation: Blown in. Insulation compressed.
- 6. Insulation Depth: 4" - Insufficient insulation present. A qualified contractor is recommended to evaluate and estimate repairs.
- 7. Vapor Barrier:
- 8. Attic Fan:
- 9. House Fan:
- 10. Wiring/Lighting:
- 11. Moisture Penetration:
- 12. Bathroom Fan Venting: Not seeing an exit point outside the attic. Bathroom improperly vents into attic and may cause moisture damage to the insulation.

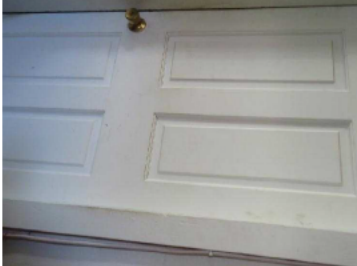
6. Service Doors: Wood. - Entry door not rated for fire. A qualified contractor is recommended to evaluate and estimate repairs.

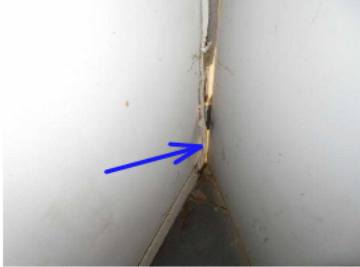
Electrical: (continued)

10. Electrical: 110 VAC. Non-GFCI circuit and the junction box needs a cover...not tape. Romex wire needs to be within the wall or in conduit. A licensed electrician is recommended to evaluate and estimate repairs.

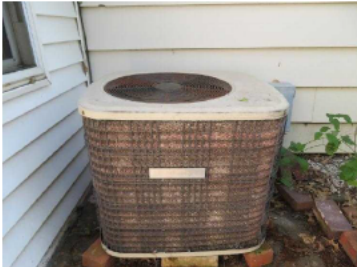
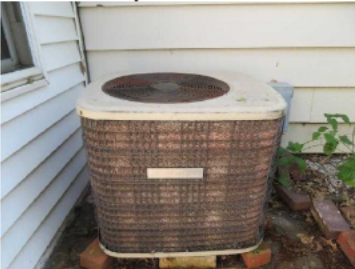
1. Exterior Unit: Pad mounted. rattles and needs to be more secured to the concrete.

10. Main AC System Exterior Unit: Pad mounted. rattles and needs to be more secured to the concrete.

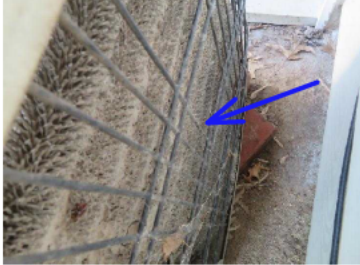
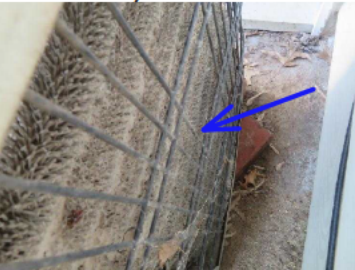
2. Visible Coil: Need to be washed off for better efficiency.

11. Main AC System Visible Coil: Need to be washed off for better efficiency.

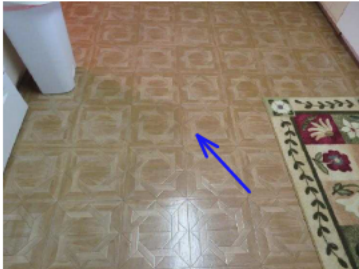
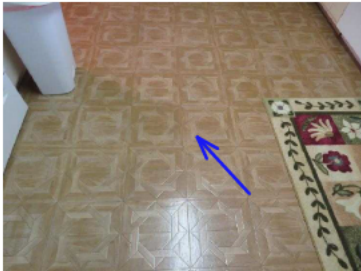
17. Floor: Linoleum. The floor squeaks when walked on.

17. 1st Floor Kitchen Floor: Linoleum. The floor squeaks when walked on.

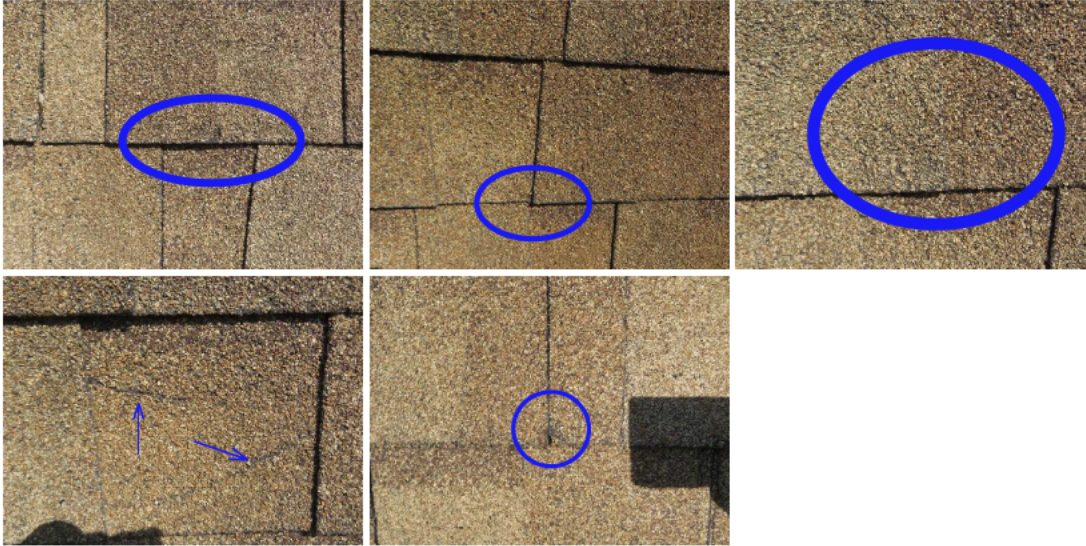
1. Main Roof Surface Material: Asphalt shingle. little nicked up but still good life left.

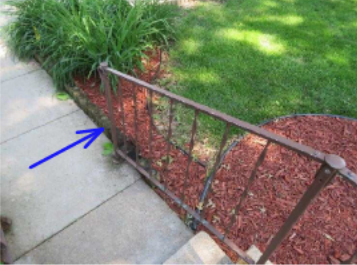
4. Porch: Concrete. railing a little loose.

5. Porch: Concrete. railing a little loose.

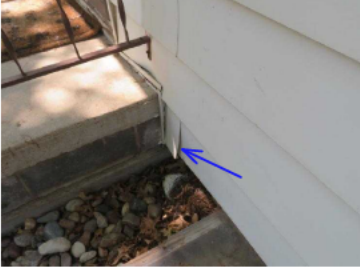
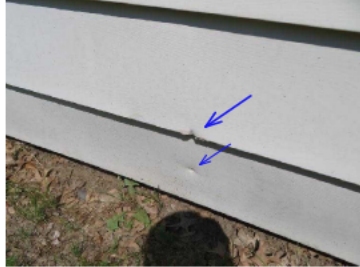
Type: (continued)

1. Type: Vinyl siding. Nick and loose in a few spots

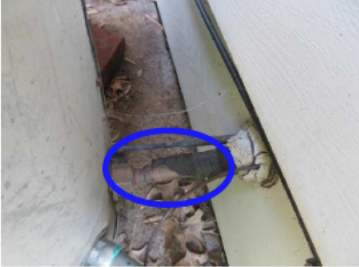
Refrigerant Lines: (continued)

8. Refrigerant Lines: Torn insulation and needs to be replaced/added to keep cooling lines insulated.

12. Main AC System Refrigerant Lines: Torn insulation and needs to be replaced/added to keep cooling lines insulated.

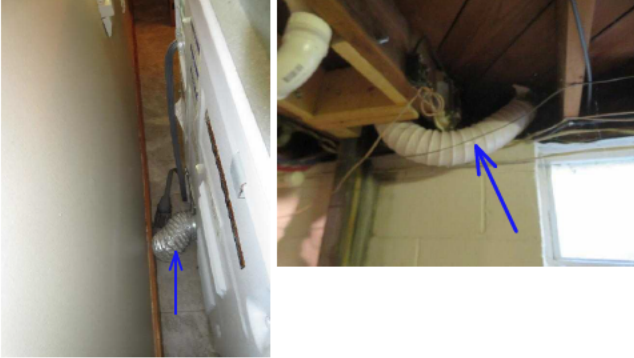
Dryer Vent: (continued)

14. Dryer Vent: Metal flex. Recommend rigid pipe.

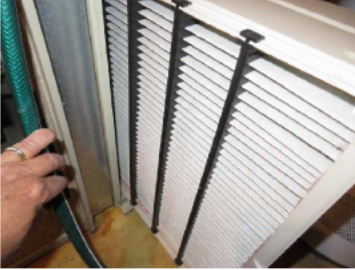
24. Basement Heating System Blower Fan/Filter: filter a little dirty.

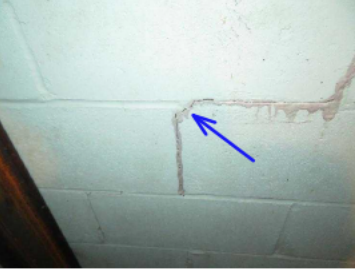
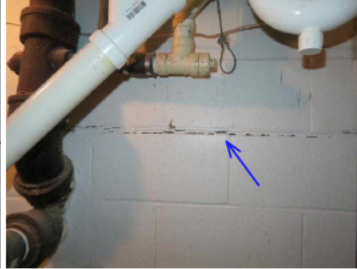
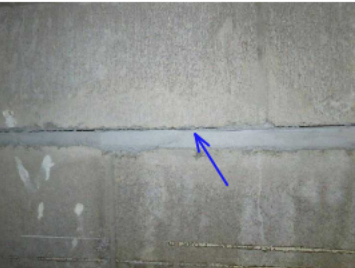
25. Foundation: Block. Cracks noted, seal and monitor for future movement.

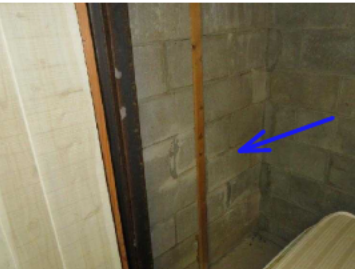
26. Differential Movement: Cracks and bow will require monitoring. We have from 1 to 1 1/2 movement on North and South walls.

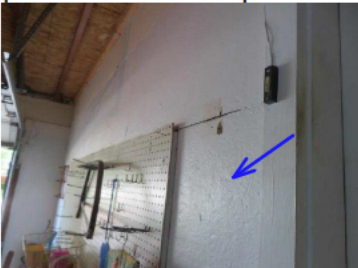
8. Walls: not fire rated - Wall is not fire resistant to the home. Recommend a qualified contractor to provide cost for repair.

5. Side Garage Walls: not fire rated - Wall is not fire resistant to the home. Recommend a qualified contractor to provide cost for repair.
